INDOOR AIR QUALITY ASSESSMENT

**Ralph B. O'Maley Middle School
32 Cherry Street
Gloucester, Massachusetts**

Prepared by:
Massachusetts Department of Public Health
Center for Environmental Health
Emergency Response/Indoor Air Quality Program
March 2006

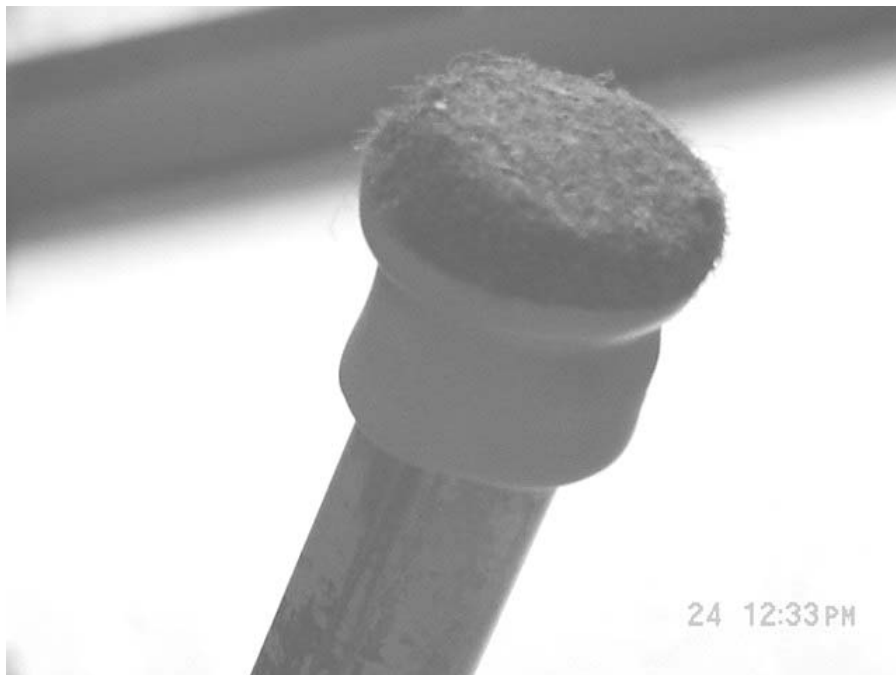
22. Consider discontinuing the use of tennis balls on chair legs to prevent latex dust generation. Alternative “glides” can commonly be purchased from office supply stores; see Picture 28 for an example.

“Glides” for Chair Legs that can be used as an Alternative to Tennis Balls

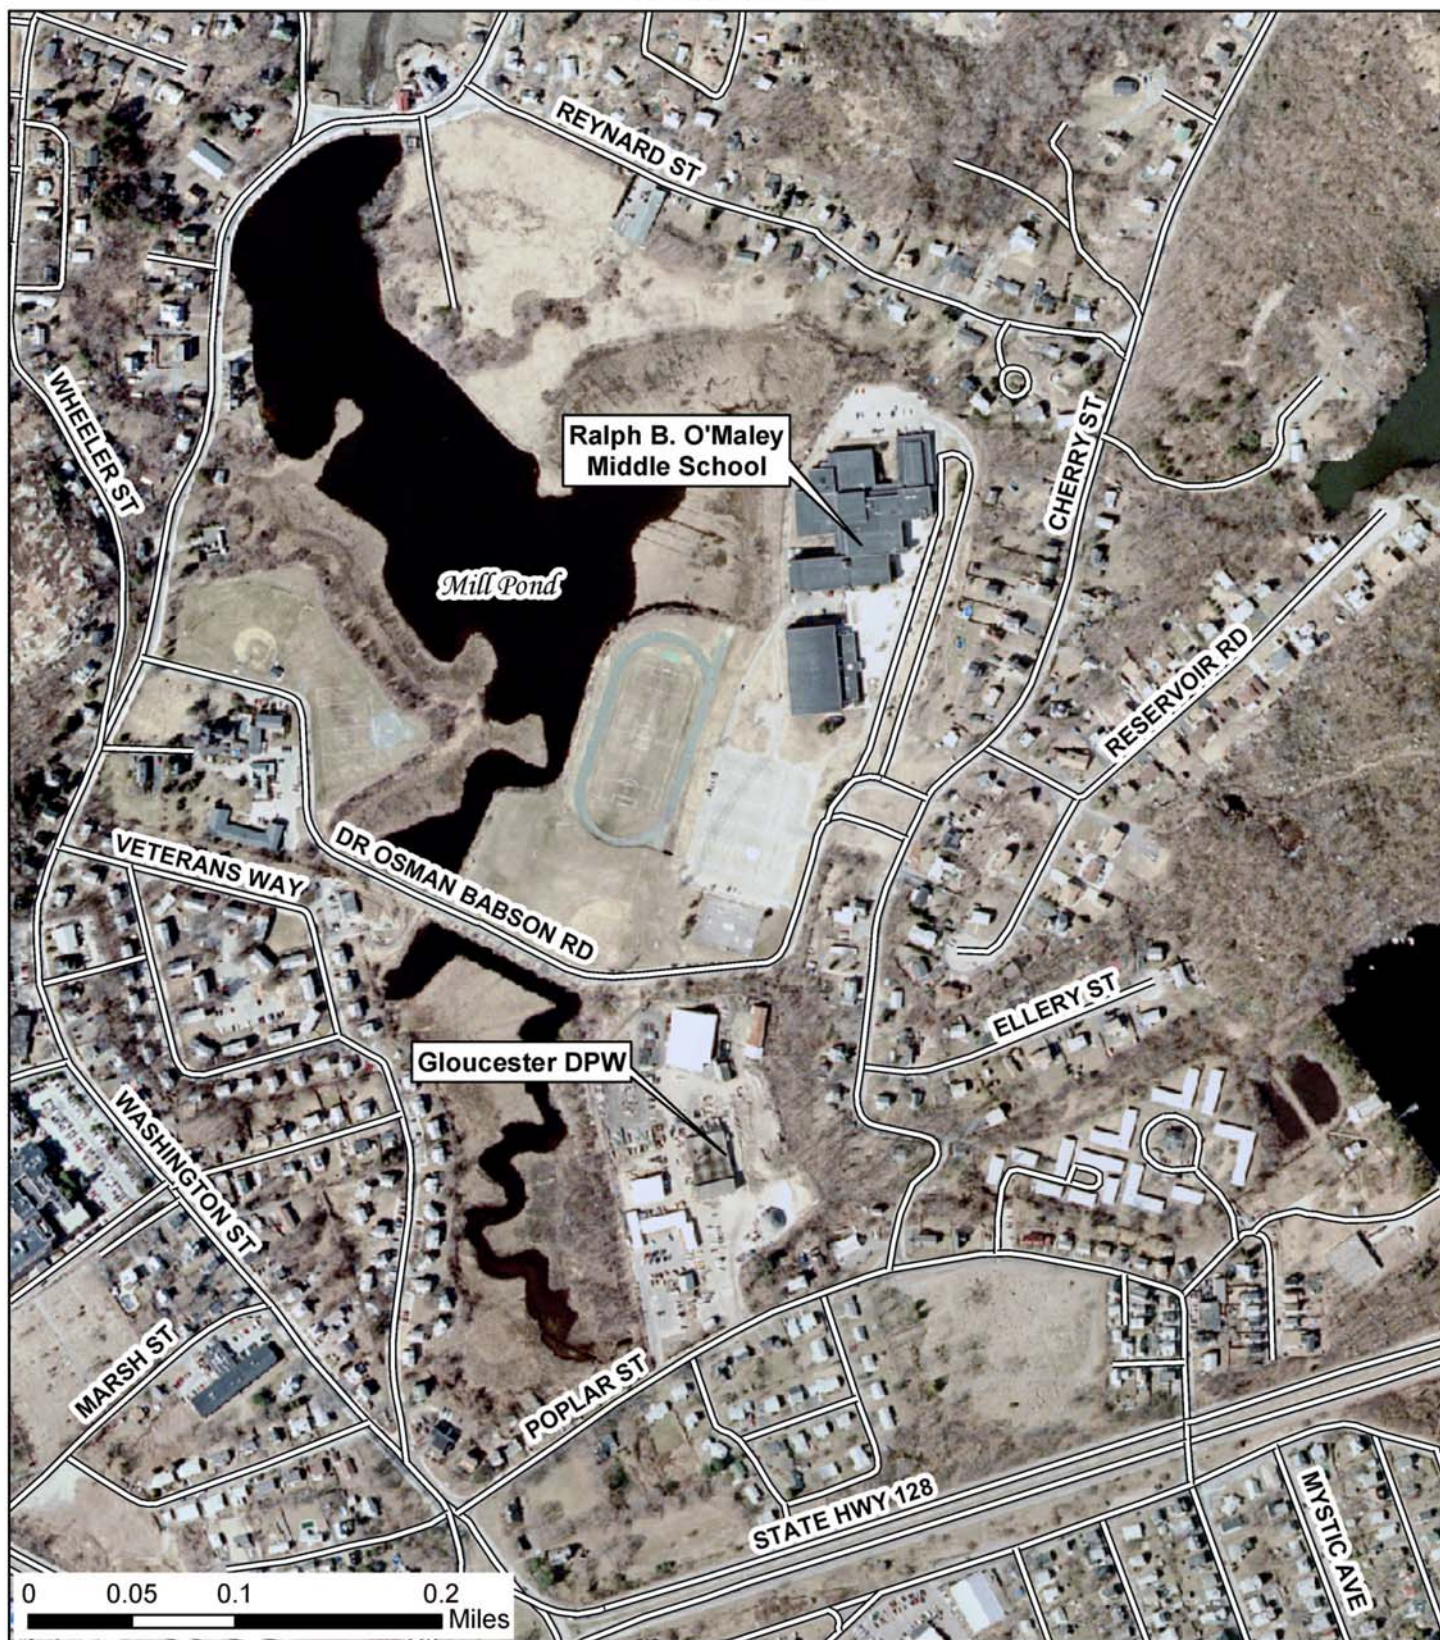
Figure 1
Location of Ralph B. O'Maley Middle School and Gloucester DPW
Gloucester, MA

Occupant complaints related to sewer-gas odors has been well documented by both MDPH and MDLWD since 2002. There appear to be two main sources of these odors: one internal and one external. The external source stems from the operation of a waste water pumping station located approximately 0.3 miles south-southwest from the school (Figure 1).

Exterior of Gymnasium Fresh Air Intake, Note Air Intake Faces South in the General Direction of the Pumping Station (Approximately 0.3 Miles to the South/Southwest) see Figure 1
